View of the North elevation of the 332 Congress Street building along the rear alleyway.

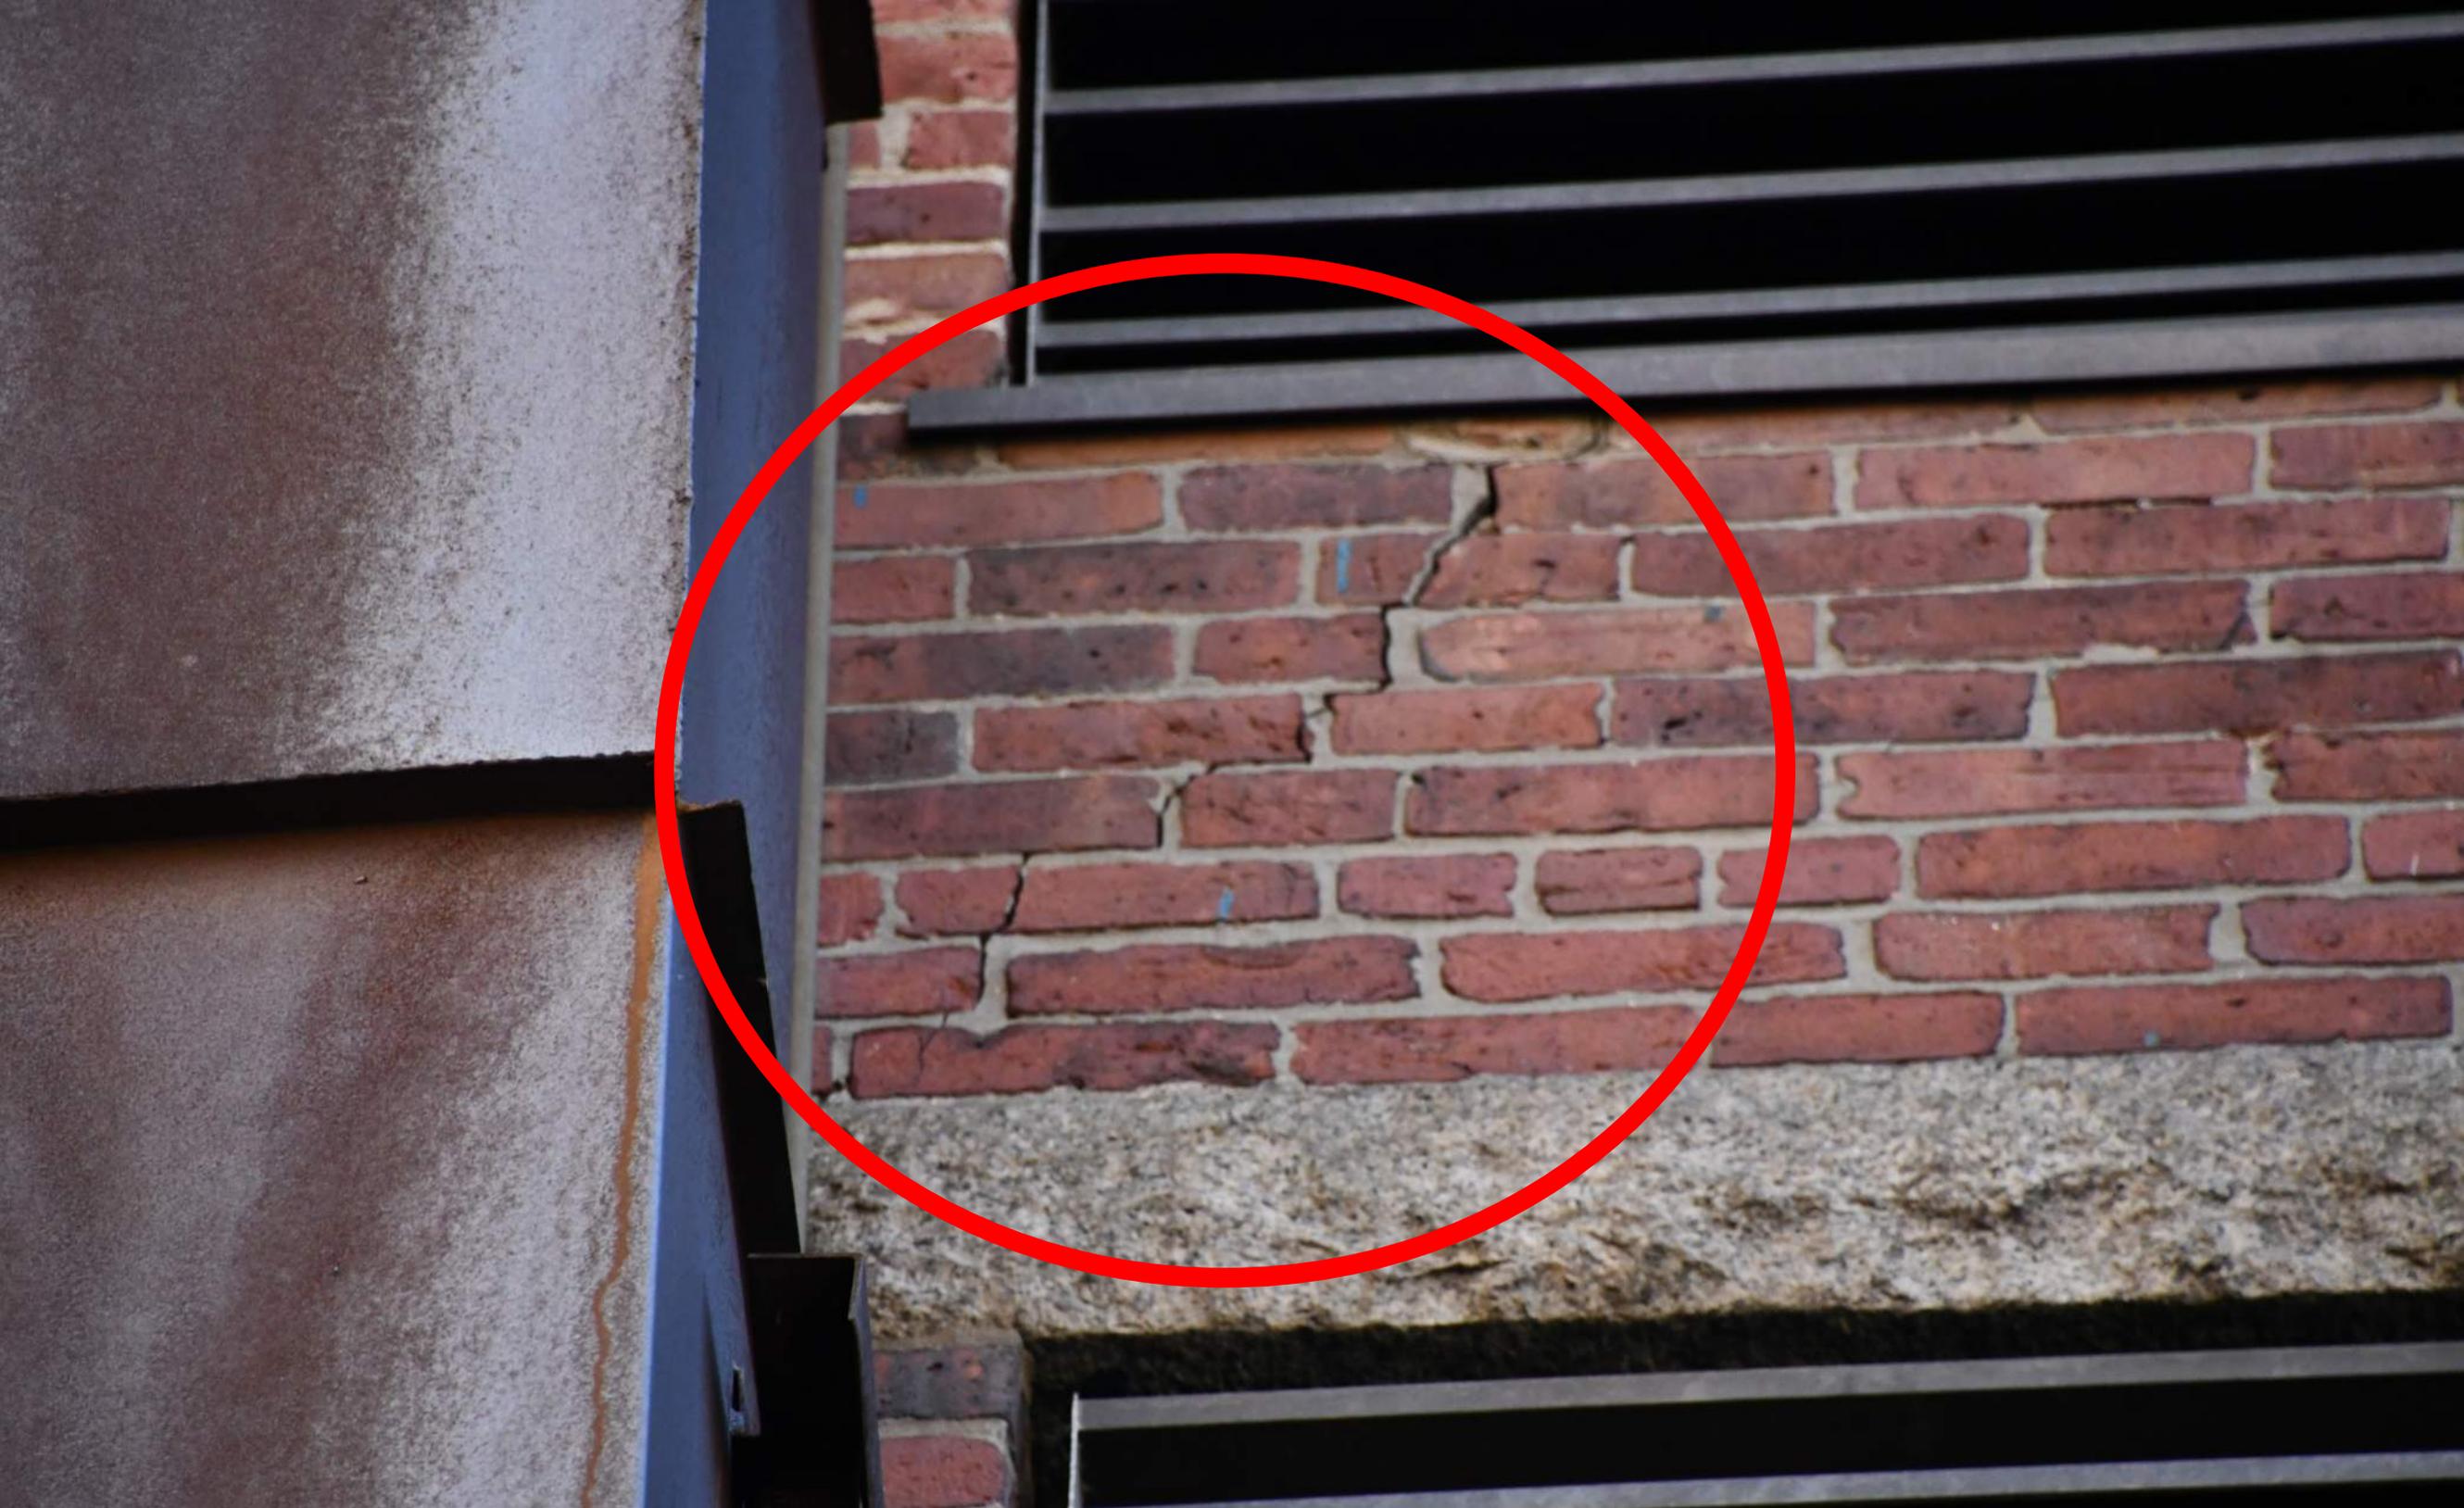
View of a brick masonry step crack with cracked brick units that will be replaced to match existing. The cracked mortar joints will be repointed.

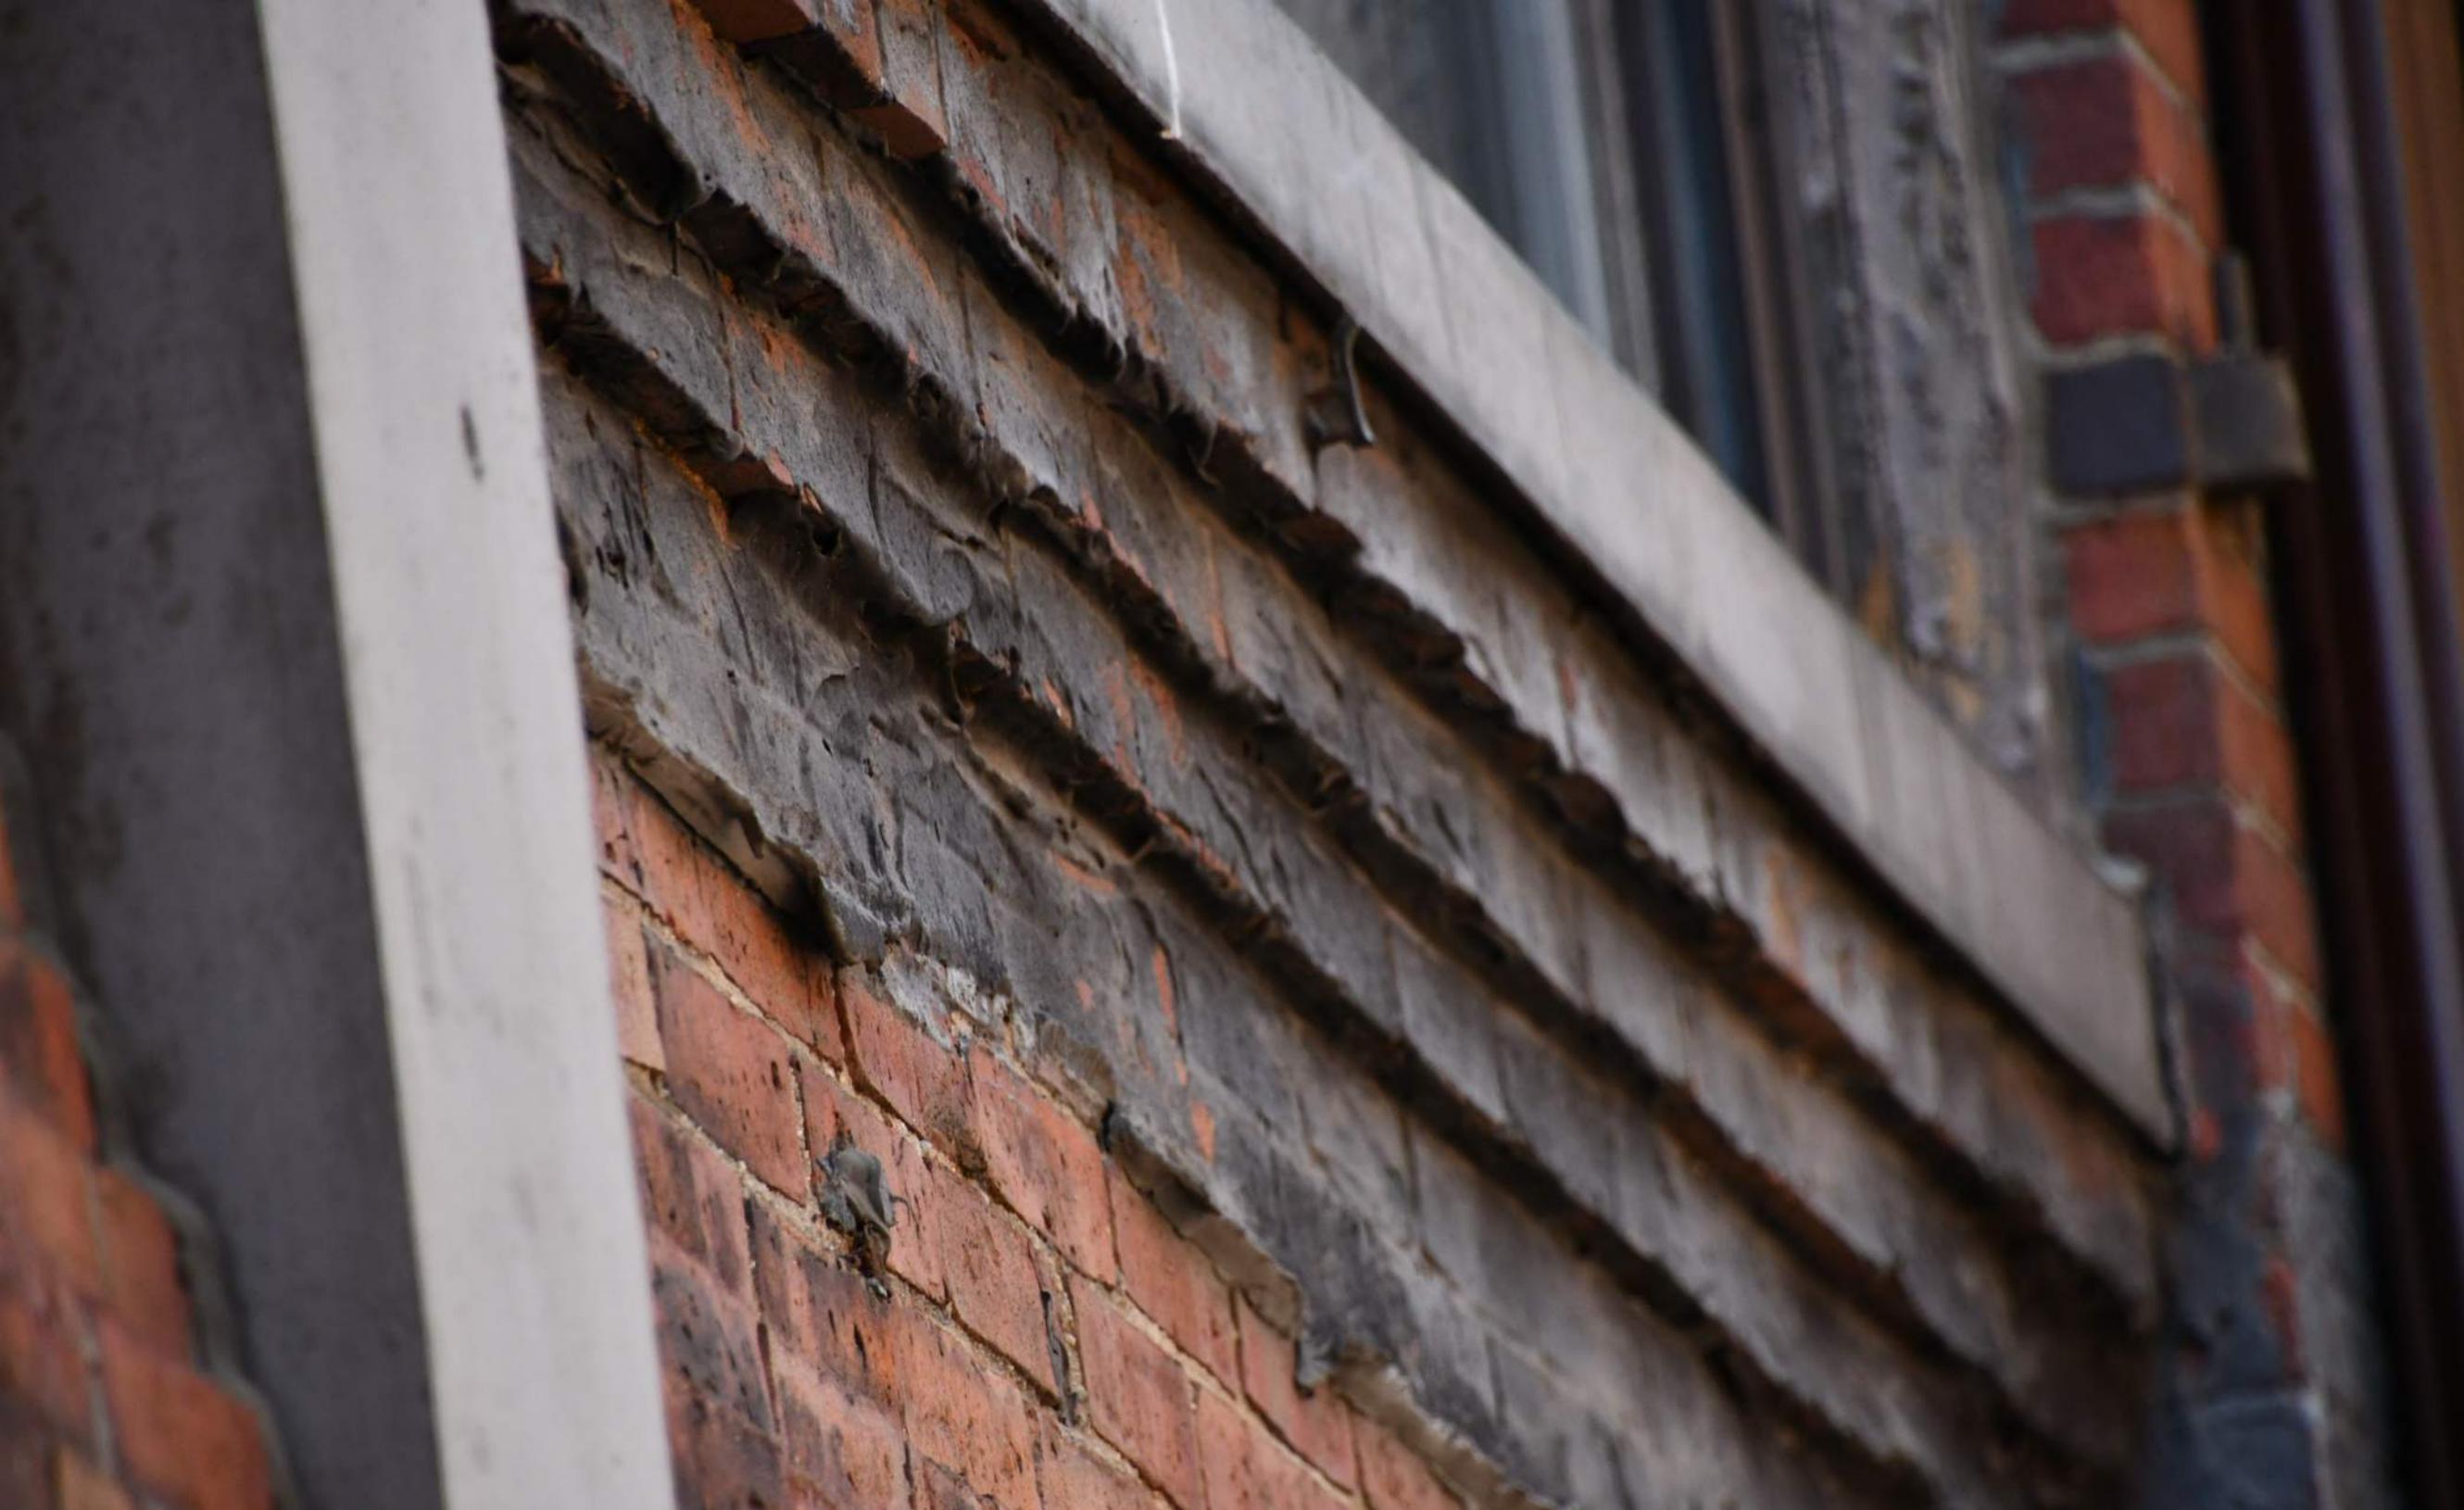
View of existing mastic on brick masonry that will be removed.

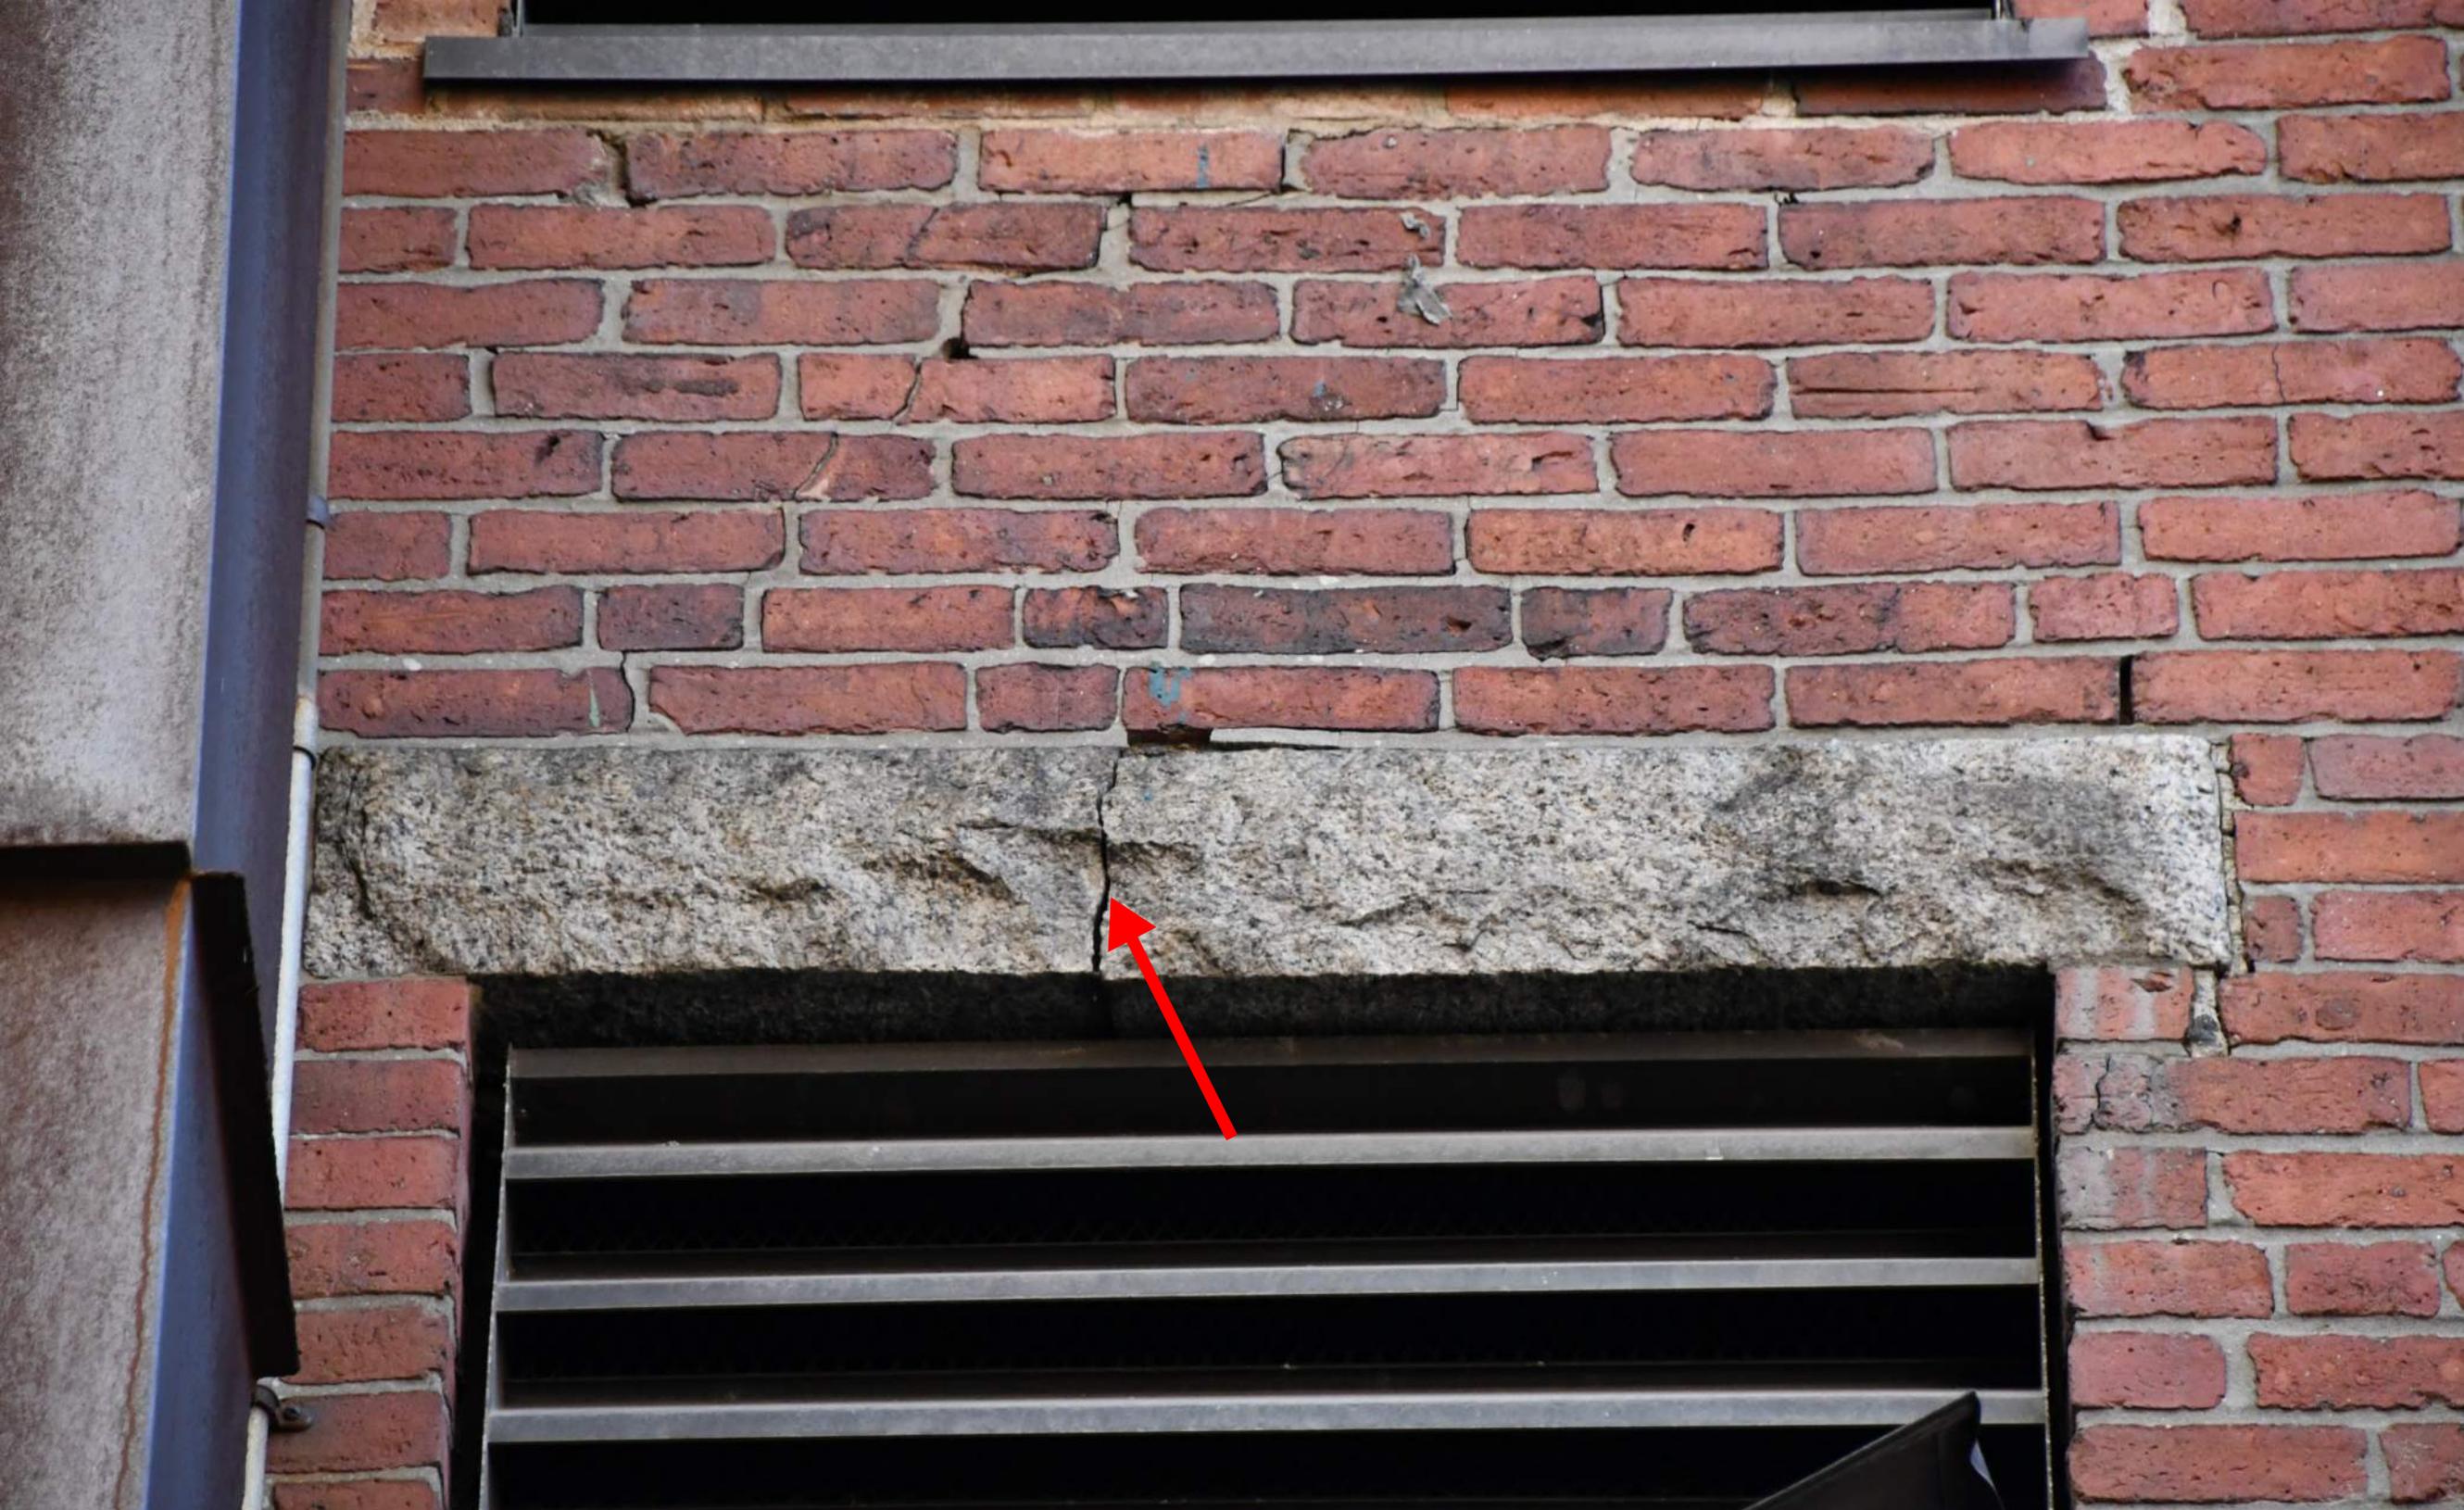
View of a cracked stone header unit that will be repaired and secured in place. The crack will be routed out and filled with a repair mortar.

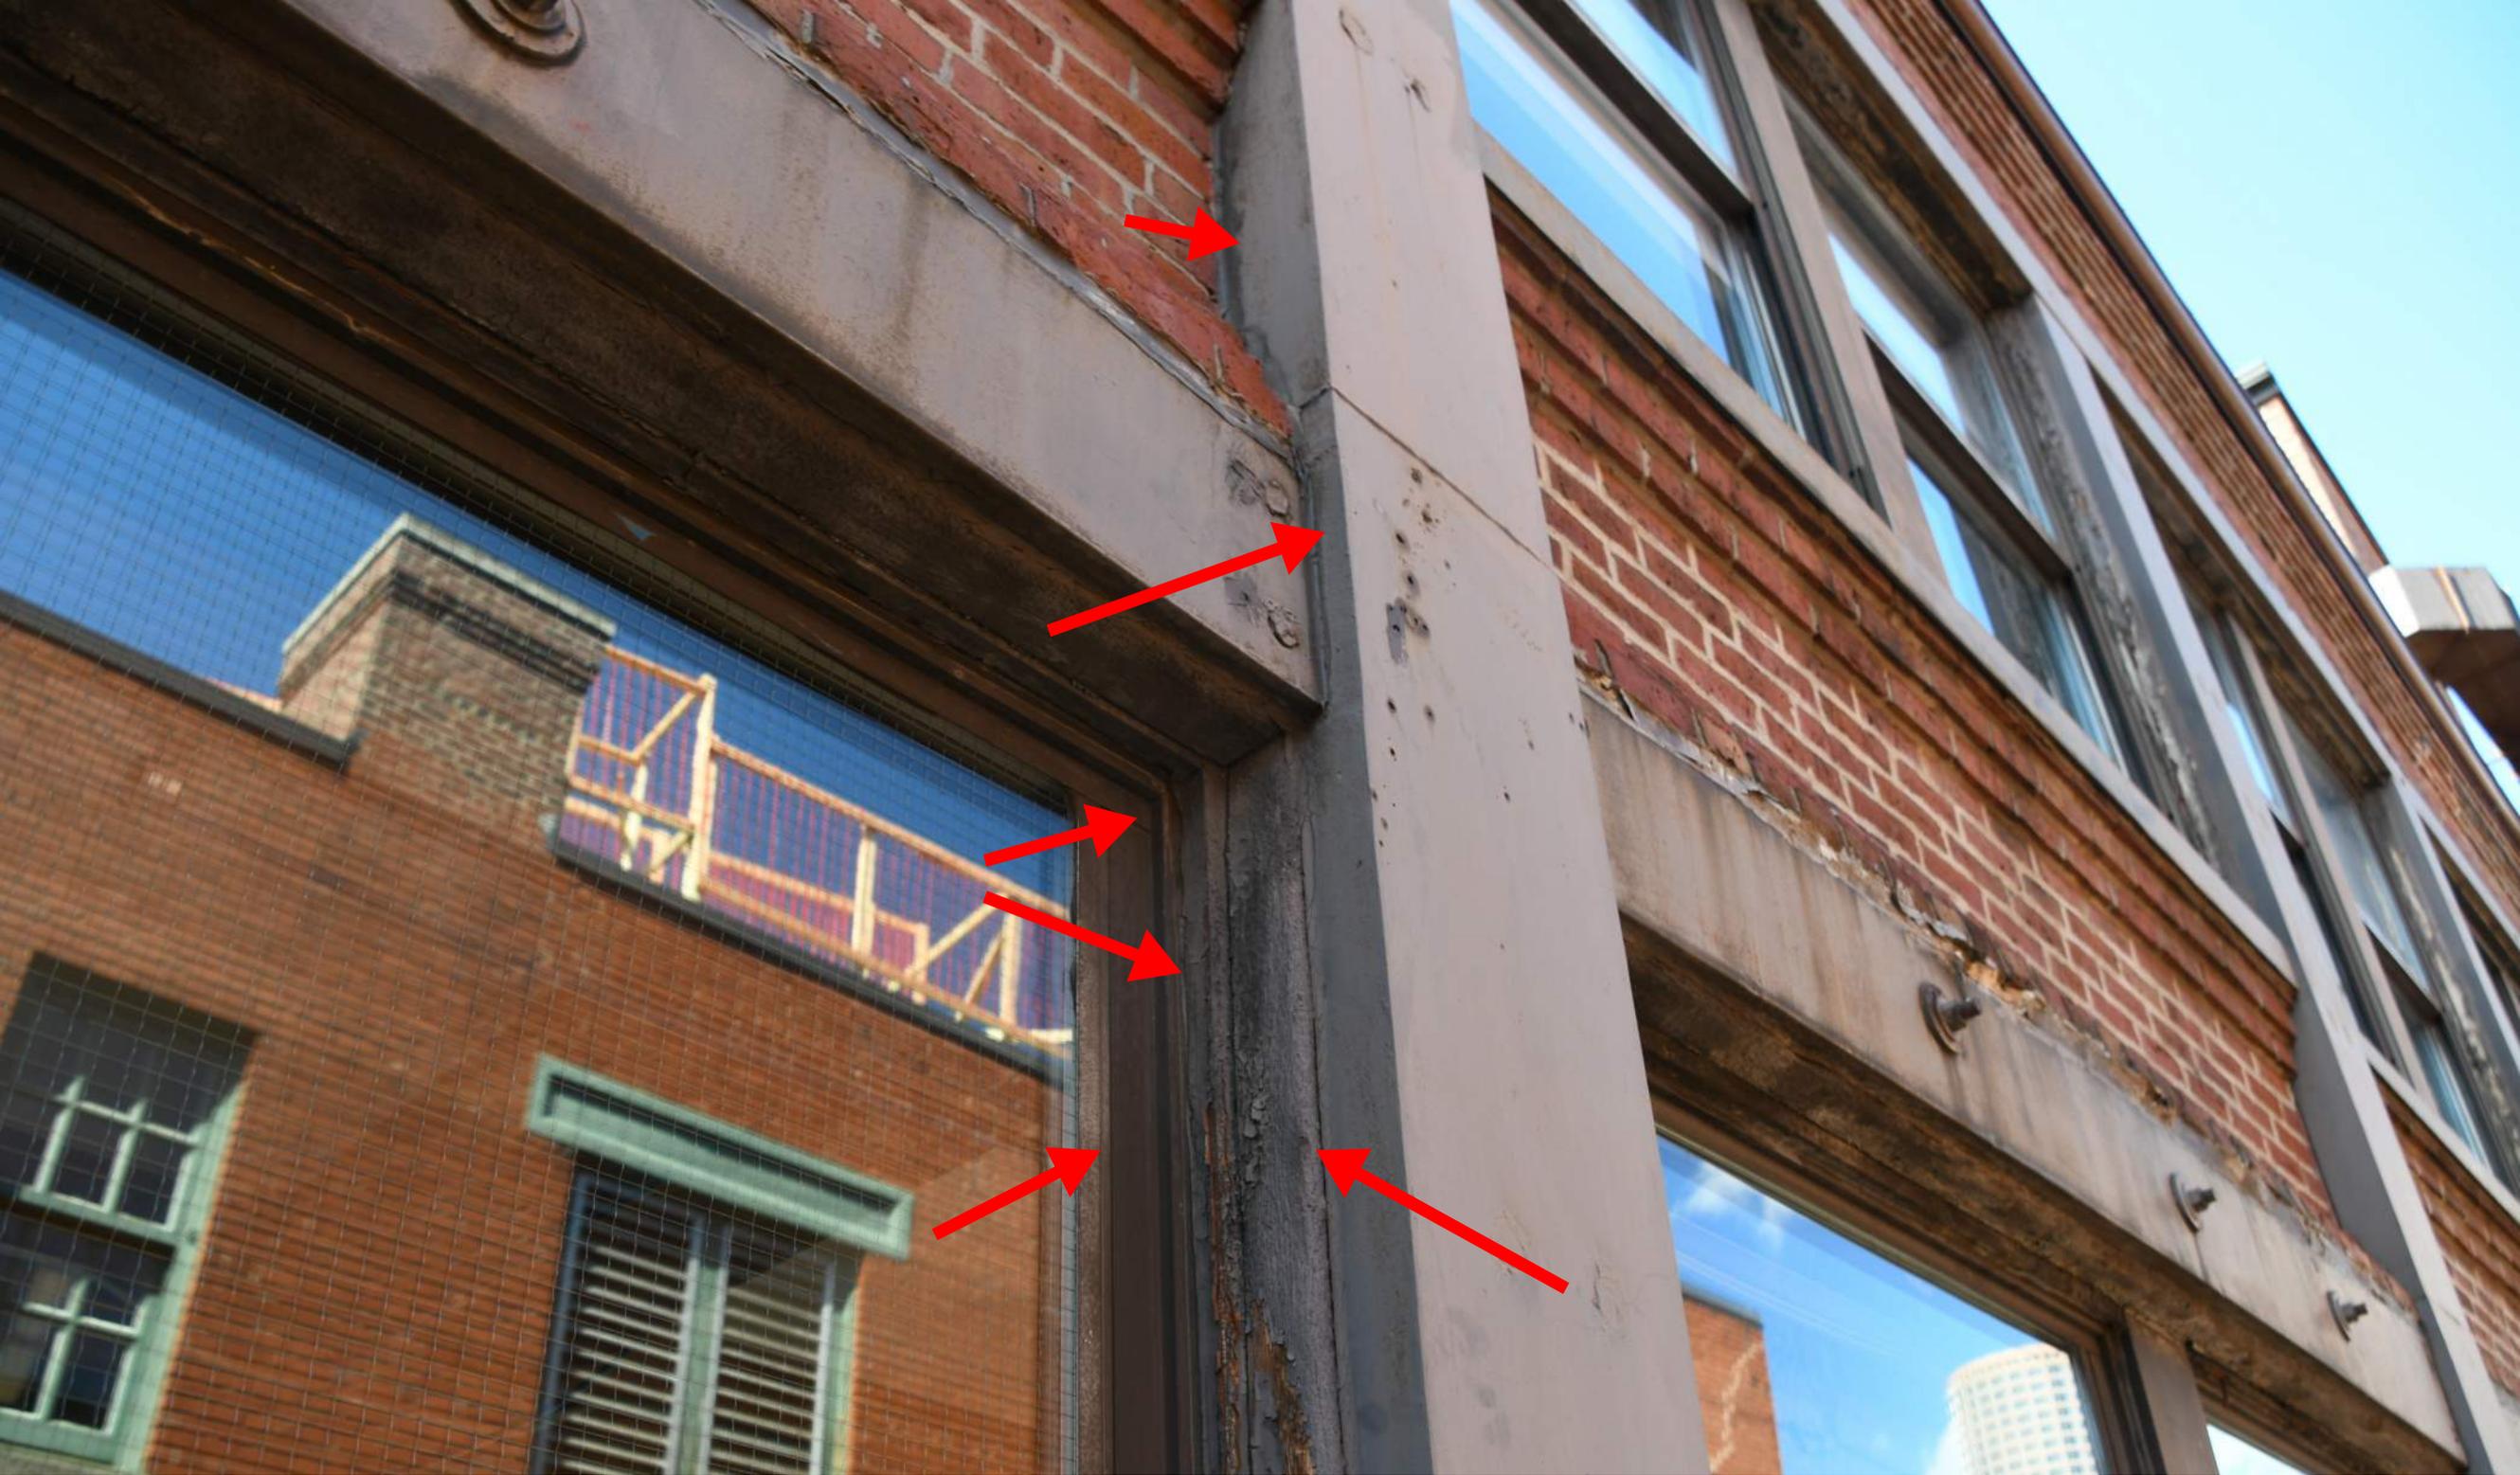
View of typical failed window sealants and deteriorated wood and cast iron paint that will all be replaced. The sealants will be replaced to match the existing in color and profile. The wood and cast iron will be scraped and repainted to match existing in color and sheen.

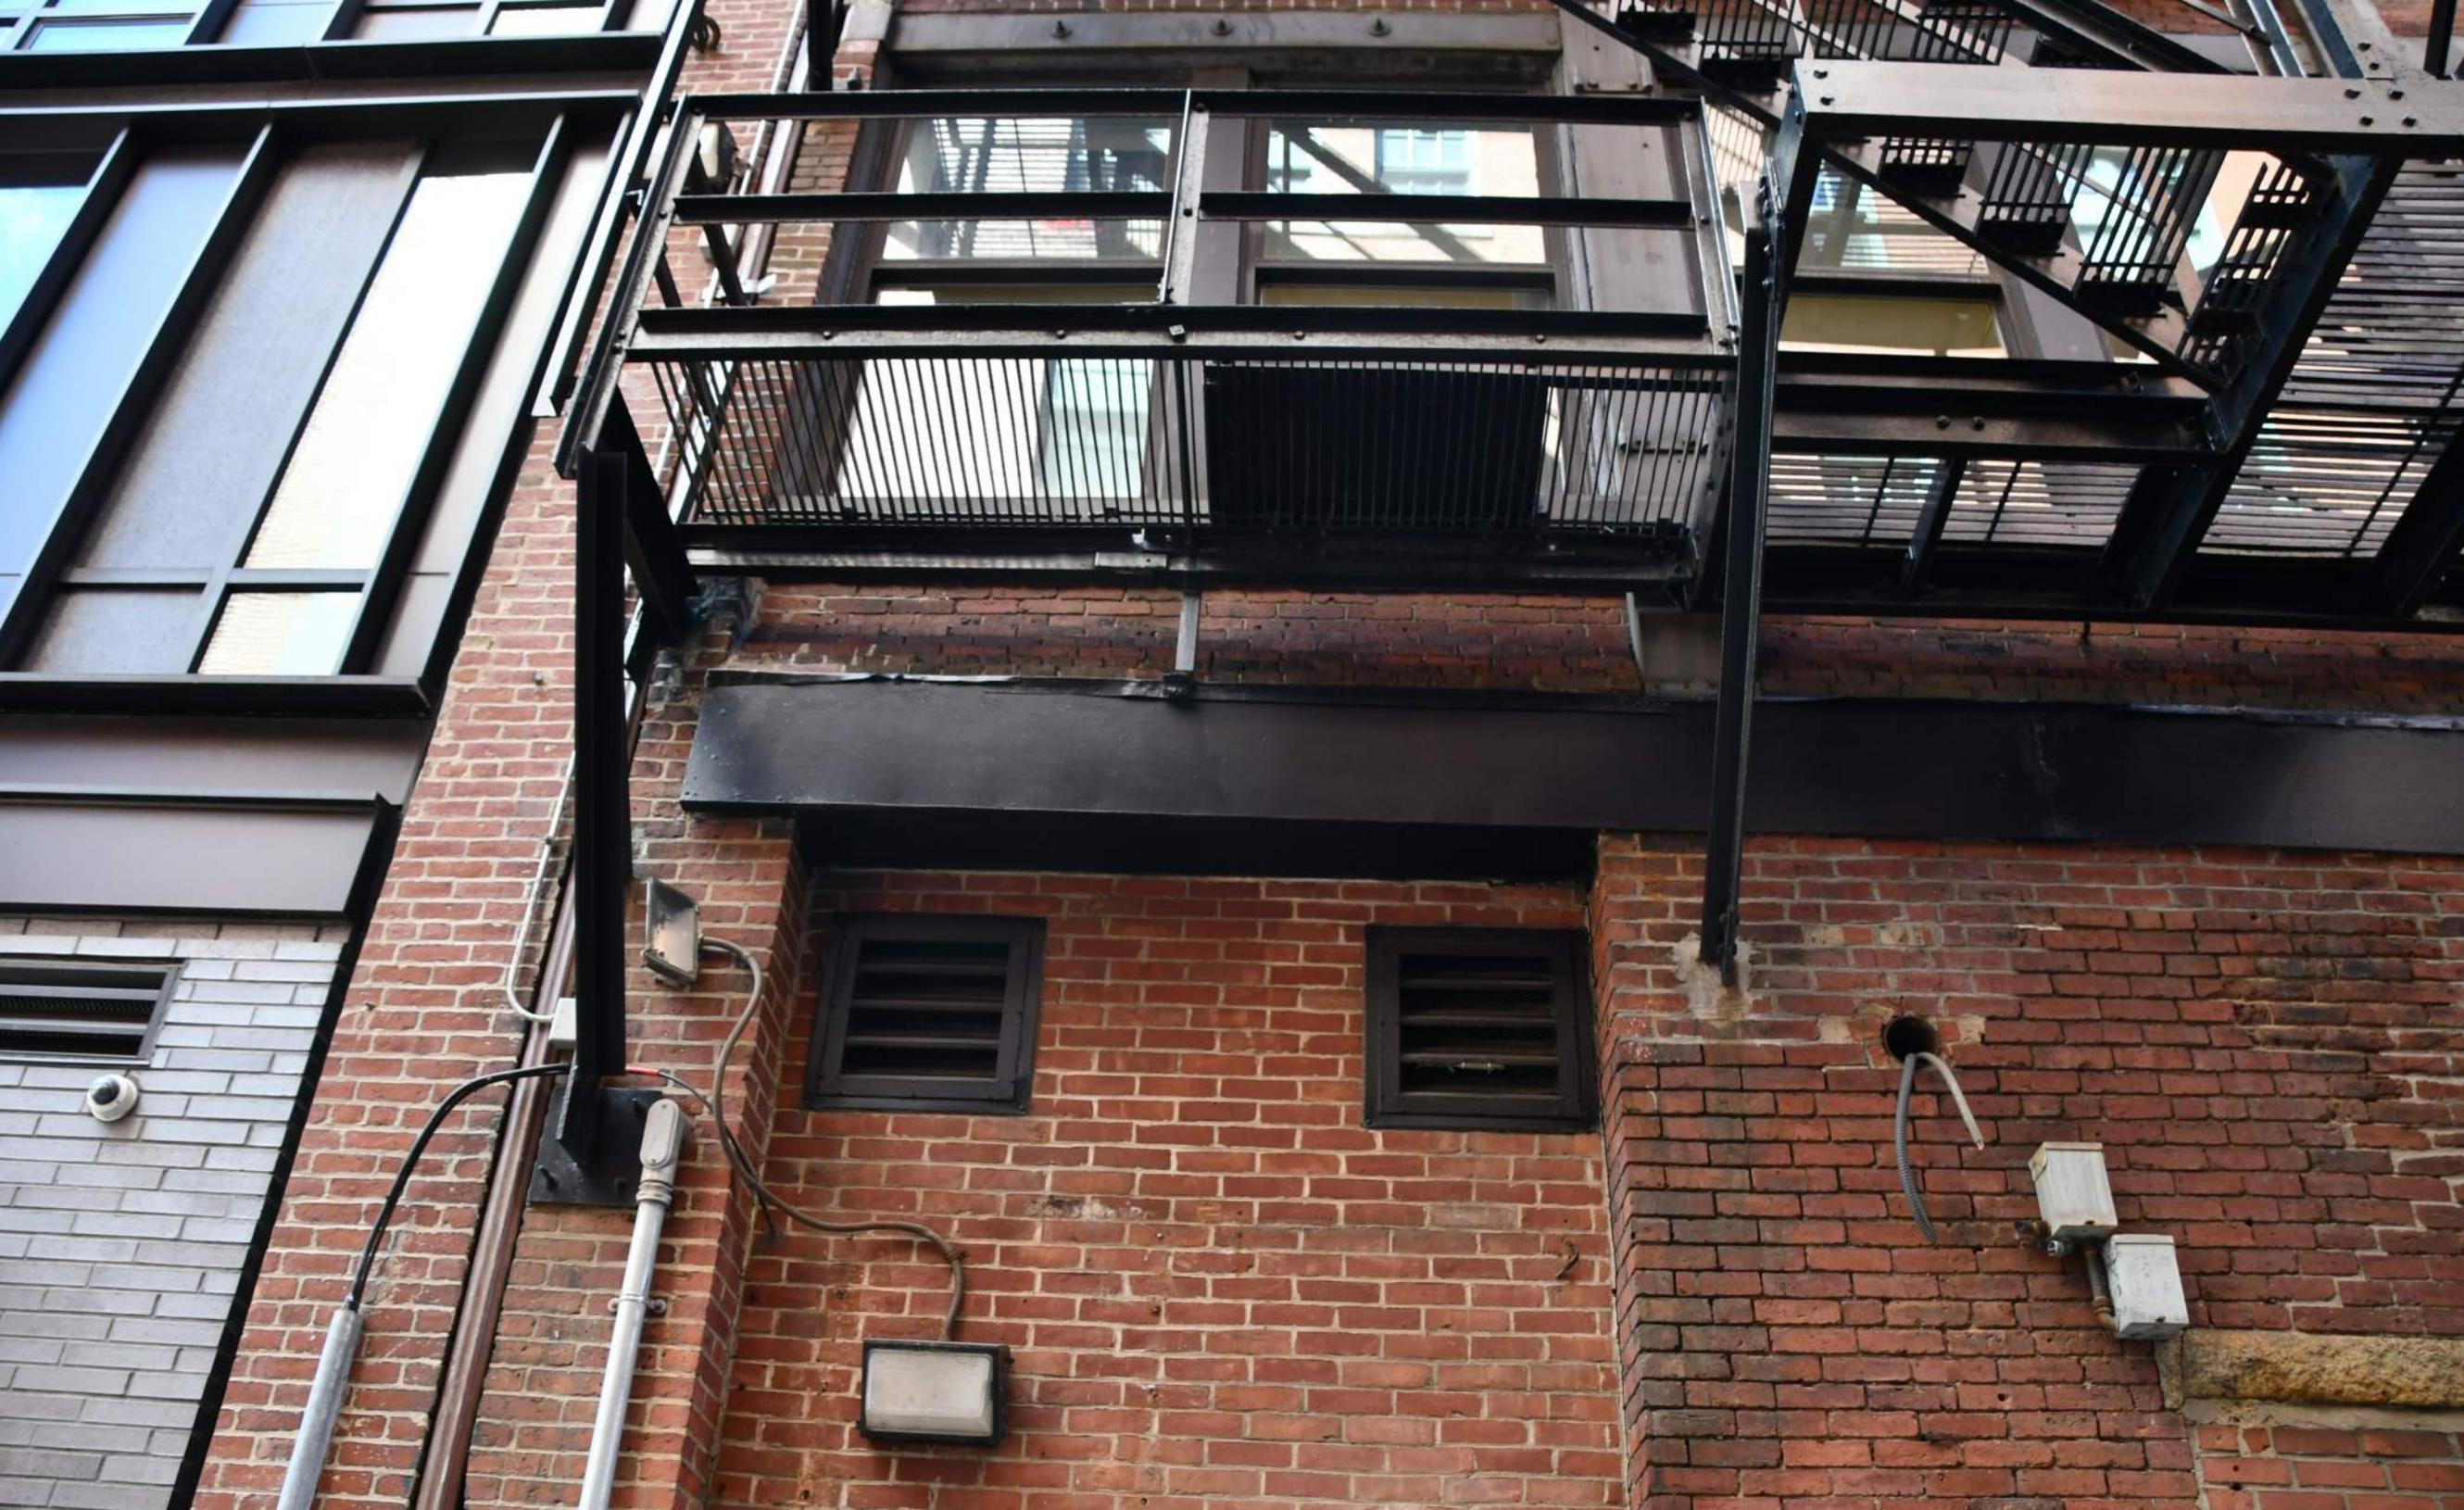
View of typical wall penetrations that will all be sealed to the brick masonry.
